# Service Bulletin

Bulletin No.: 19-NA-101

**Subject:** Possible Oil Consumption and/or Leaks

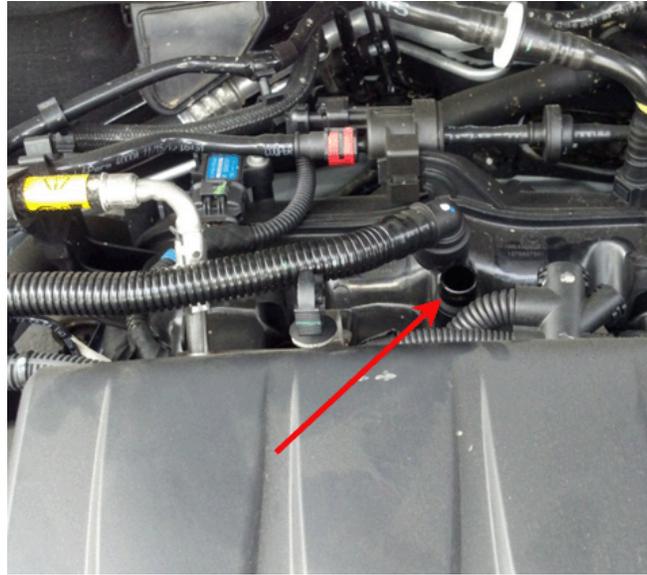
3814780

<b>Involved Region or Country</b>	North America, Israel
<b>Condition</b>	Some customers may comment on one or more of the following conditions: <ul style="list-style-type: none"><li>• Oil consumption</li><li>• Oil leak</li></ul>
<b>Cause</b>	This condition may be caused by a missing Non Return valve. ⇒ Increased crankcase pressure can force the oil into the induction system and eventually into the cylinders.

Separate the PCV bypass pipe from the intake manifold and check for a missing intake manifold Non Return Valve:

- If you can see the nipple of the Non Return valve as shown above, then no further repair is needed for the intake manifold.
- ⇒ Continue diagnosis for the oil consumption using SI.
- If the Non Return Valve is missing, replace the intake manifold.

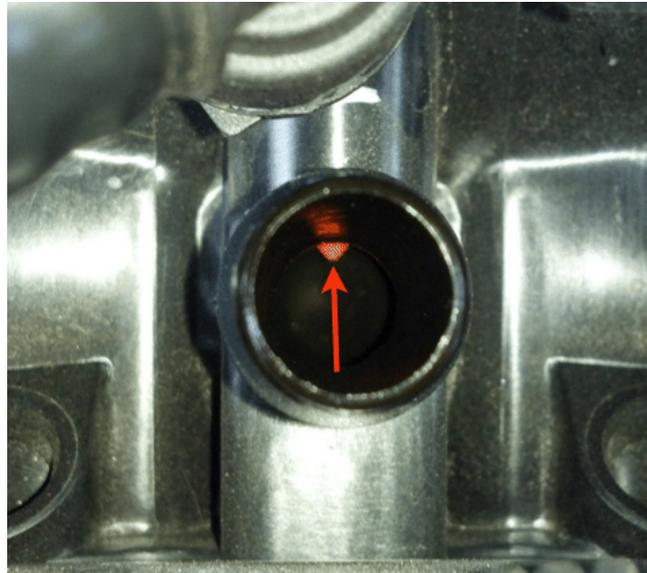
3814782

**Note:** The Non Return Valve is orange in color but could be covered in soot making it difficult to see the color.
